**DEPARTMENT OF TRANSPORTATION**

Contract #: 04-0120F4Cty: SF/ALA Rte: 80 PM: 13.2/13.9File #: 1.28**WELDING INSPECTION REPORT****Resident Engineer:** Casey, William**Address:** 333 Burma Road**City:** Oakland, CA 94607**Report No:** WIR-027694**Date Inspected:** 30-May-2012**Project Name:** SAS Superstructure**OSM Arrival Time:** 700**Prime Contractor:** American Bridge/Fluor Enterprises, a JV**OSM Departure Time:** 1730**Contractor:** American Bridge/Fluor Enterprises, a JV**Location:** jobsite**CWI Name:** William Sherwood**CWI Present:** Yes No**Inspected CWI report:** Yes No N/A**Rod Oven in Use:** Yes No N/A**Electrode to specification:** Yes No N/A**Weld Procedures Followed:** Yes No N/A**Qualified Welders:** Yes No N/A**Verified Joint Fit-up:** Yes No N/A**Approved Drawings:** Yes No N/A**Approved WPS:** Yes No N/A**Delayed / Cancelled:** Yes No N/A**Bridge No:** 34-0006**Component:** OBG**Summary of Items Observed:**

**OBG Deck Access Holes**

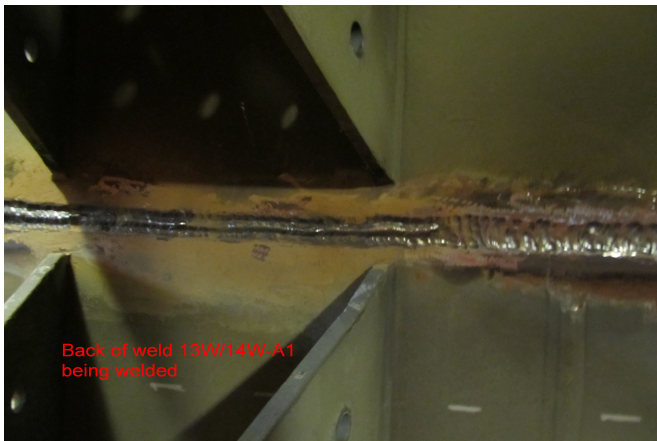
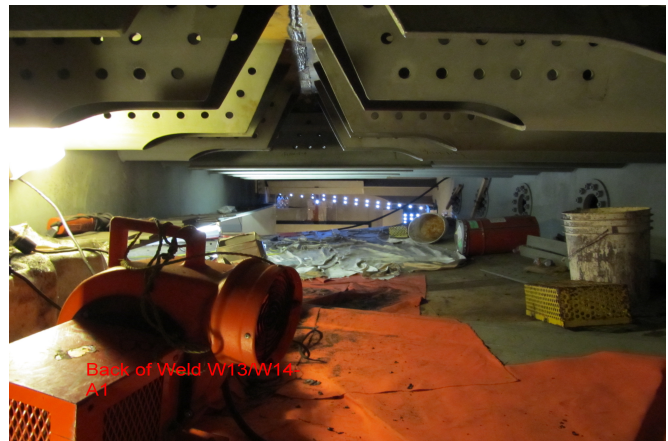
This QAI observed the welding of the back gouged backside of weld joint 13W-14W-A1. The welding was being performed by Michael Jiminez in the 4G position using the Shield Metal Arc Welding (SMAW) Process at 126 amps using an E7018H4R consumable electrode.
